JULY–AUGUST 1996

Dubrovnik-bound Flight Crew's Improperly Flown Nonprecision Instrument Approach Results in Controlled-flight-into-terrain Accident

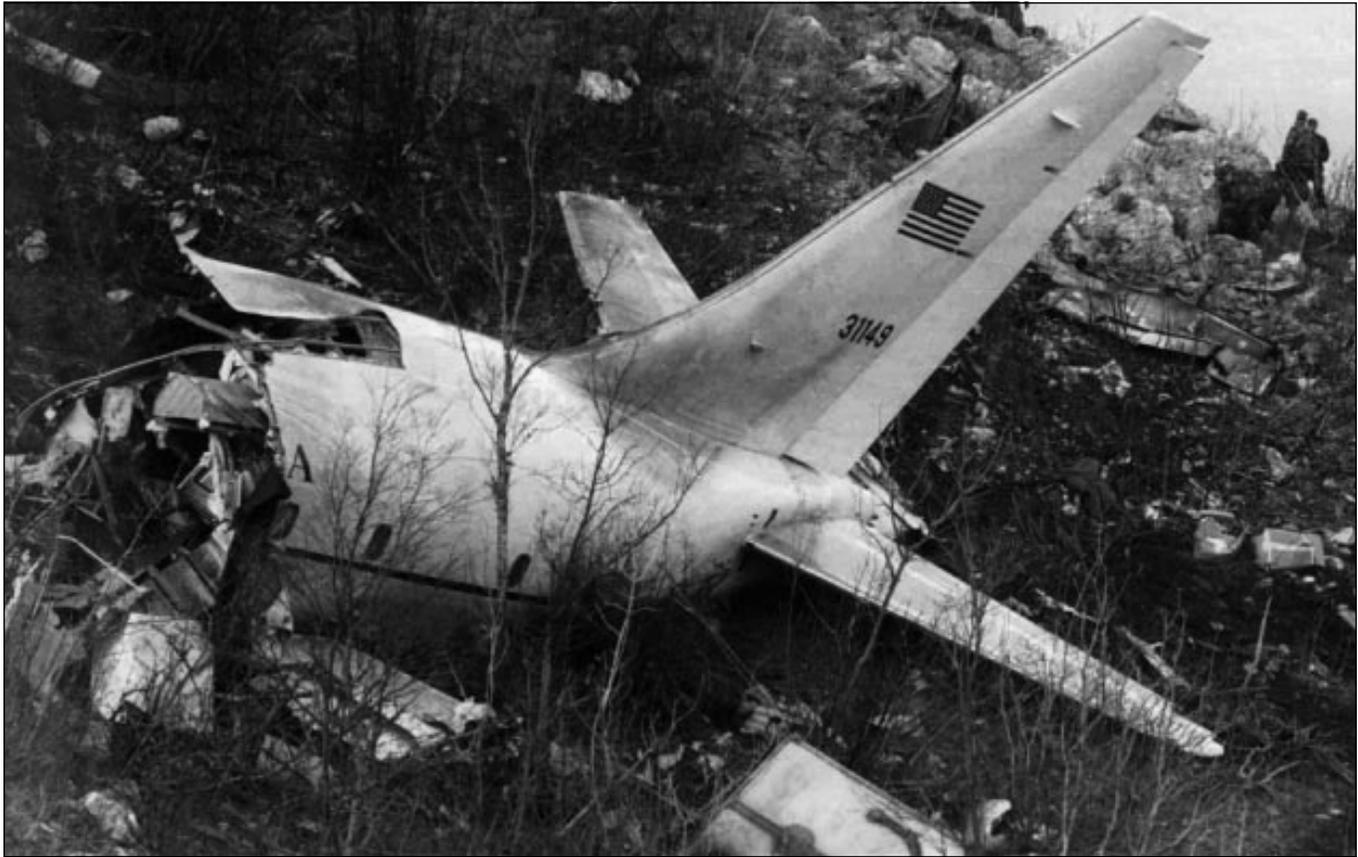
Wreckage of the U.S. Air Force CT-43A that crashed near Dubrovnik, Croatia, on April 3, 1996, killing U.S. Department of Commerce Secretary Ron Brown and all 34 others on board.

Examination of the wreckage revealed fire damage that was characteristic of postimpact fire. Fractured surfaces exhibited characteristics of overload that were consistent with high-energy impact with the ground. There was no preimpact failure or separation of the aircraft structure. Evidence of fatigue or corrosion that could have precipitated preimpact failure was not found on any major component.”

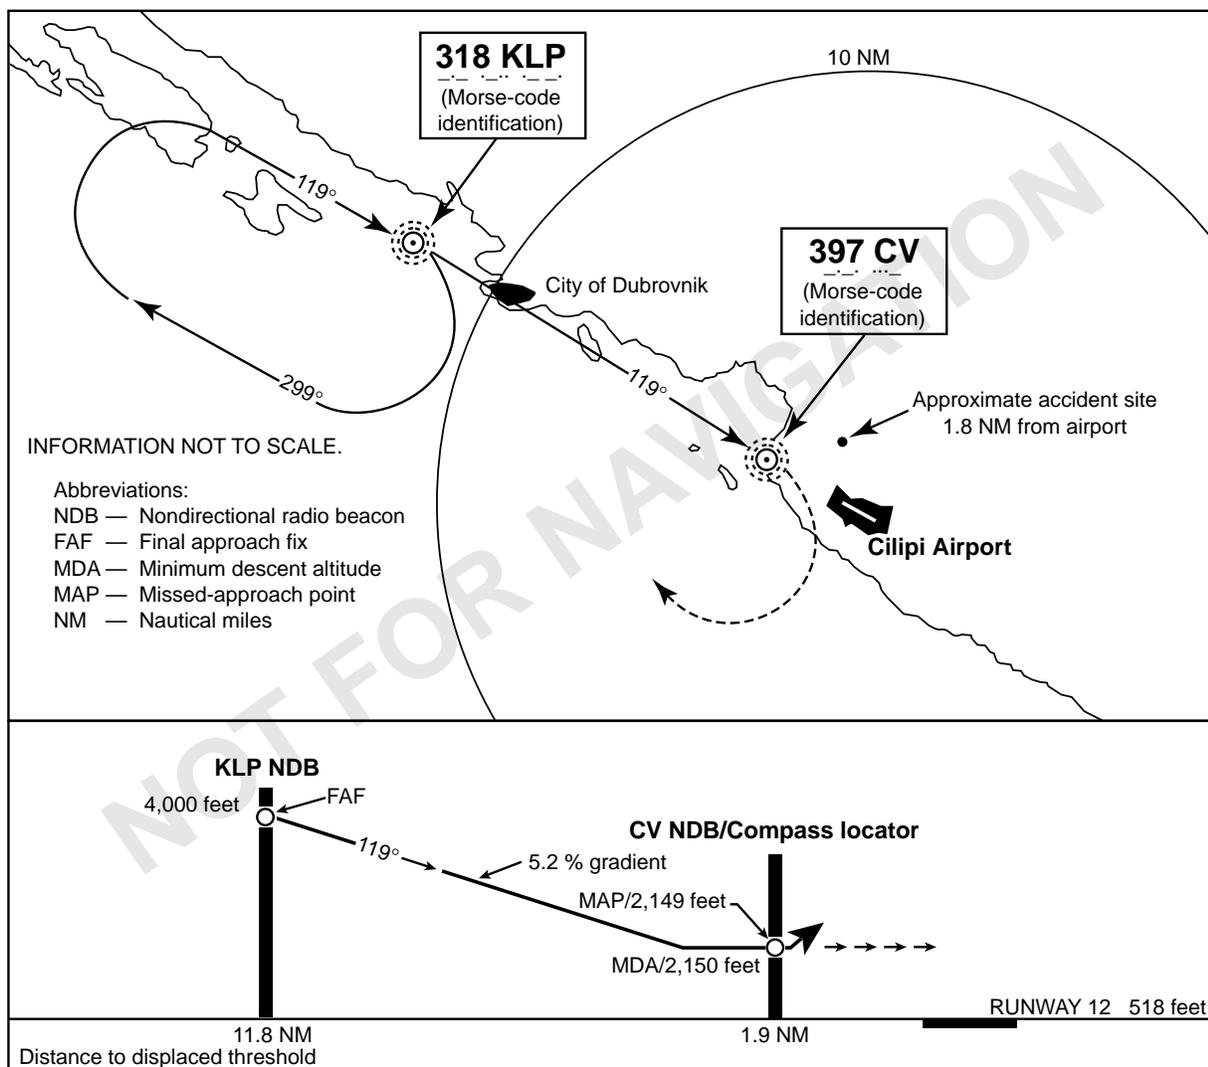
Figure 2

Illustration of NDB Approach to Runway 12, Cilipi Airport, Dubrovnik, Croatia

The report noted: “In order to fly the approach, the air crew must be able to maintain positive course guidance and determine the missed-approach point. For this approach, timing may not be used as the primary method to determine the missed-approach point, in accordance with the Jeppesen approach chart legend; however, timing is recommended as a backup in the event of problems with the primary method,” the report said.

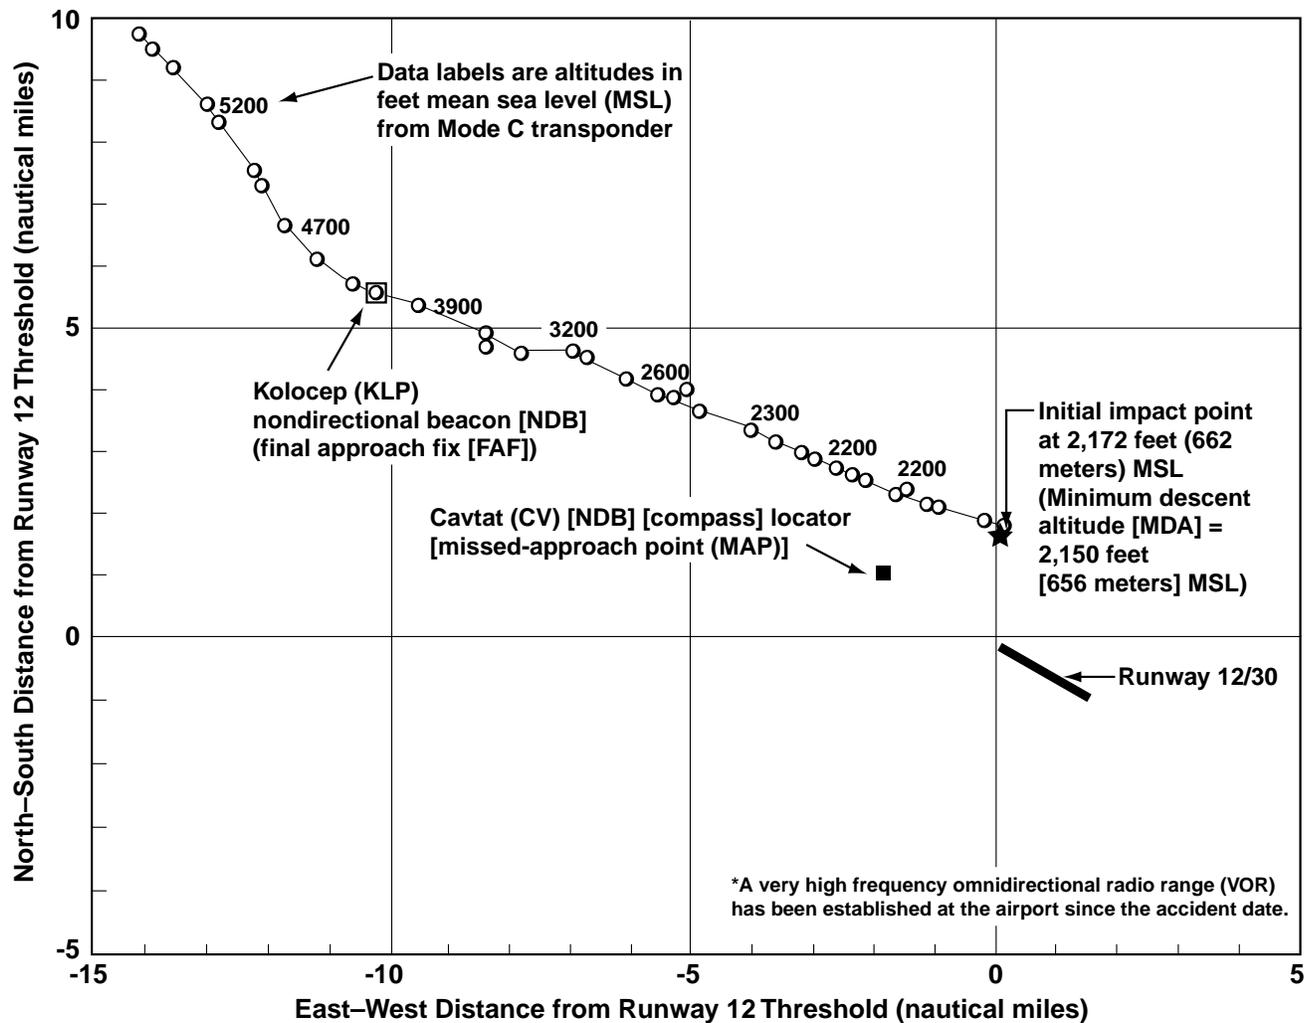
Figure 3

Reconstruction of Final Approach Flown by Accident Crew, U.S. Air Force CT-43A, Dubrovnik, Croatia, April 3, 1996

The report noted: “The flight manual also requires an aircraft to be fully configured with landing gear down and landing flaps extended when crossing the [FAF].” Based on these indicated airspeeds and the maximum flap airspeeds found in the flight manual, the [accident] aircraft’s flaps were not set for landing and would have been between the zero and 10 flap setting (normal setting for landing is flaps at 30).”

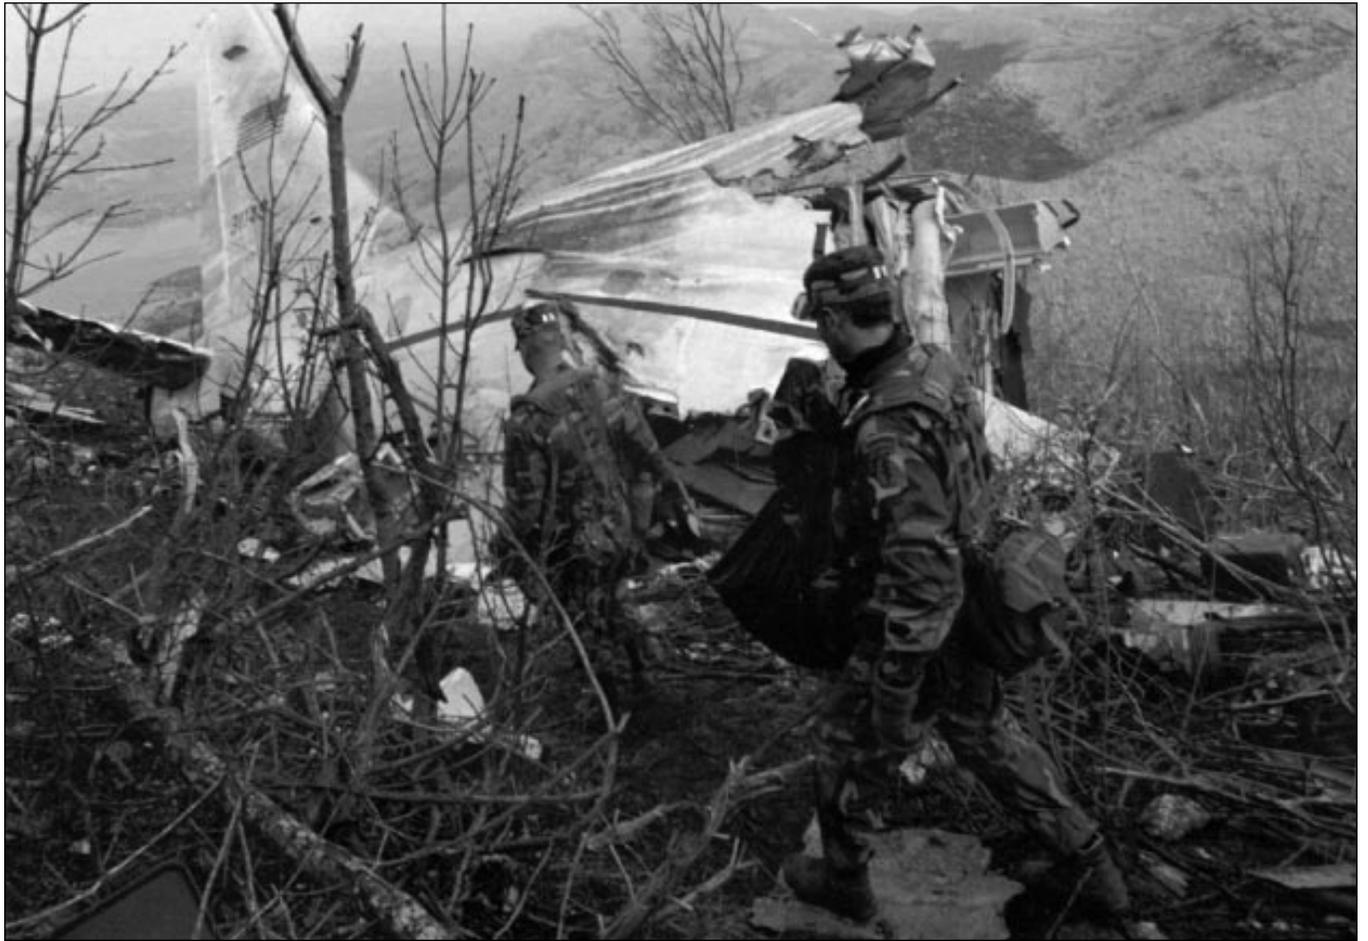
The empennage was located and found "upslope from the initial impact area and oriented on a heading of approximately 90 degrees," the report said. "It was upright but resting on its left side and the left horizontal-stabilizer tip due to the incline of the hill. This section [extended] from the forward

U.S. Army investigators walk toward wreckage of rear fuselage and empennage of U.S. Air Force CT-43A that crashed on approach to Dubrovnik, Croatia.

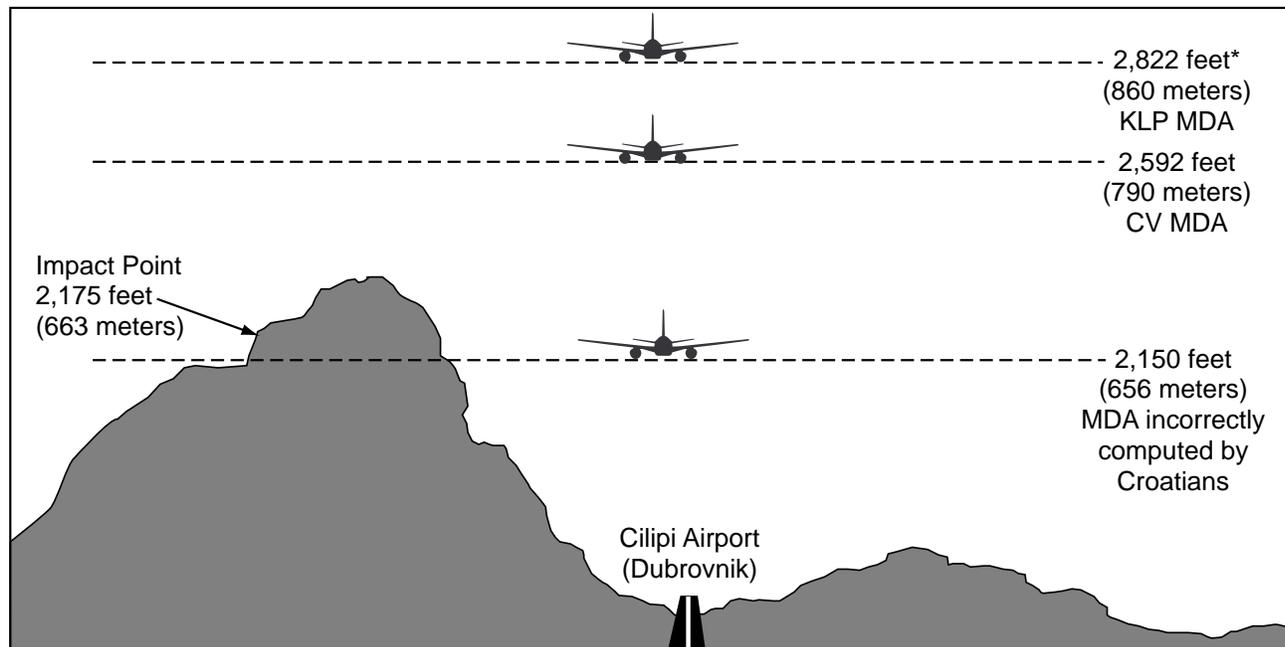
“Correct application of both the U.S. and [ICAO] standards would result in a higher [MDA] than published by the host nation”

Minimum Descent Altitudes (MDAs) Based on ICAO Criteria

* KLP and CV MDAs correctly computed by accident investigators using International Civil Aviation Organization (ICAO) criteria. [Editorial note: KLP and CV are nondirectional radio beacons (NDBs).]
